GLULAM BEAMS KEEP DUCK FANS DRY

University of Oregon's Autzen Stadium Renovation

Project Summary

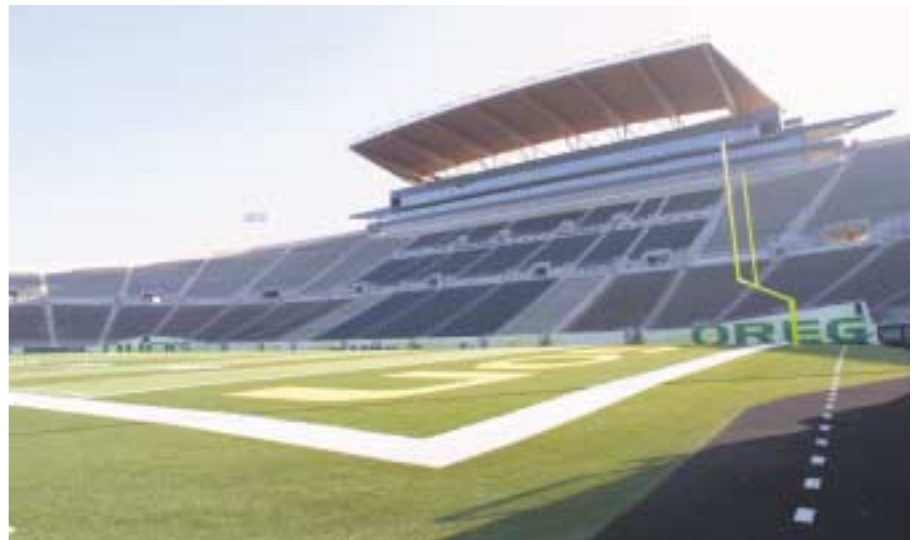
Autzen Stadium's new glulam roof structure cantilevers dramatically over enthusiastic (and now dry) Duck fans.

What may appear as most striking to fans is the glulam roof canopy that cantilevers 97 feet over the new donor seats, protecting loyal Duck fans from Oregon's fall and winter rains.

The resulting members had hundreds of bolts, and each 97-foot segment weighed 35,000 pounds. The glulam girders were then carefully lifted by crane into place, for a total assembled length of 171 feet. Once in place, the girders were supported by steel columns as well as by 57-foot-long steel knee braces that extended out from each column.

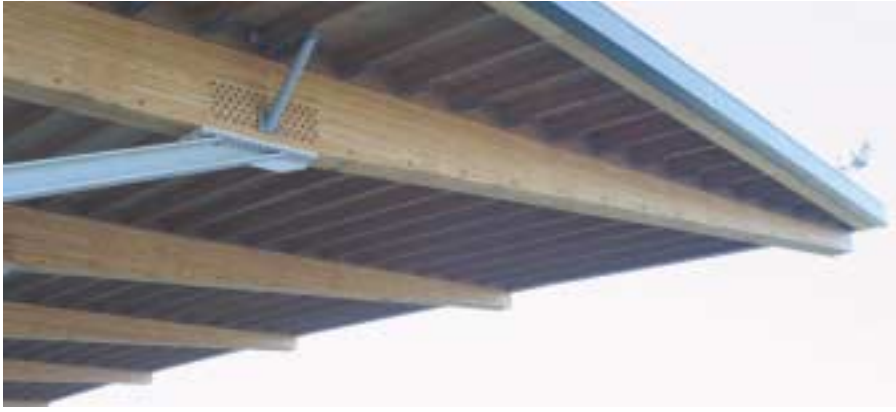
The glulam canopy was cambered, heightening the importance of accurate on-site fabrication and installation.

To complicate matters, the glulam canopy that cantilevered out toward the playing field was both cambered and arched. Detailed coordination was required to make sure each beam settled into the right plane before the next was erected.

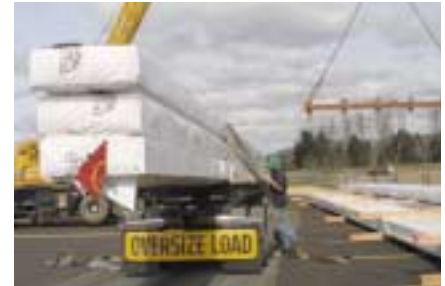
More than 430,000 board feet of Douglas-fir glulam was used in the project.

The sheer size of the project makes it notable, both in terms of the stadium itself and in the number, size and span of the glulam beams. Glulam members were manufactured from 430,000 board feet of Douglas-fir using 24F-V4 and 24F-V8 layups. Girders were fabricated from two 12-1/4-inch-wide beams bolted together,
